GROUNDWATER RESOURCES INVESTIGATION REPORT - RUGGED SOLAR FARM

Groundwater Resources Investigation Report Rugged Solar Farm Project

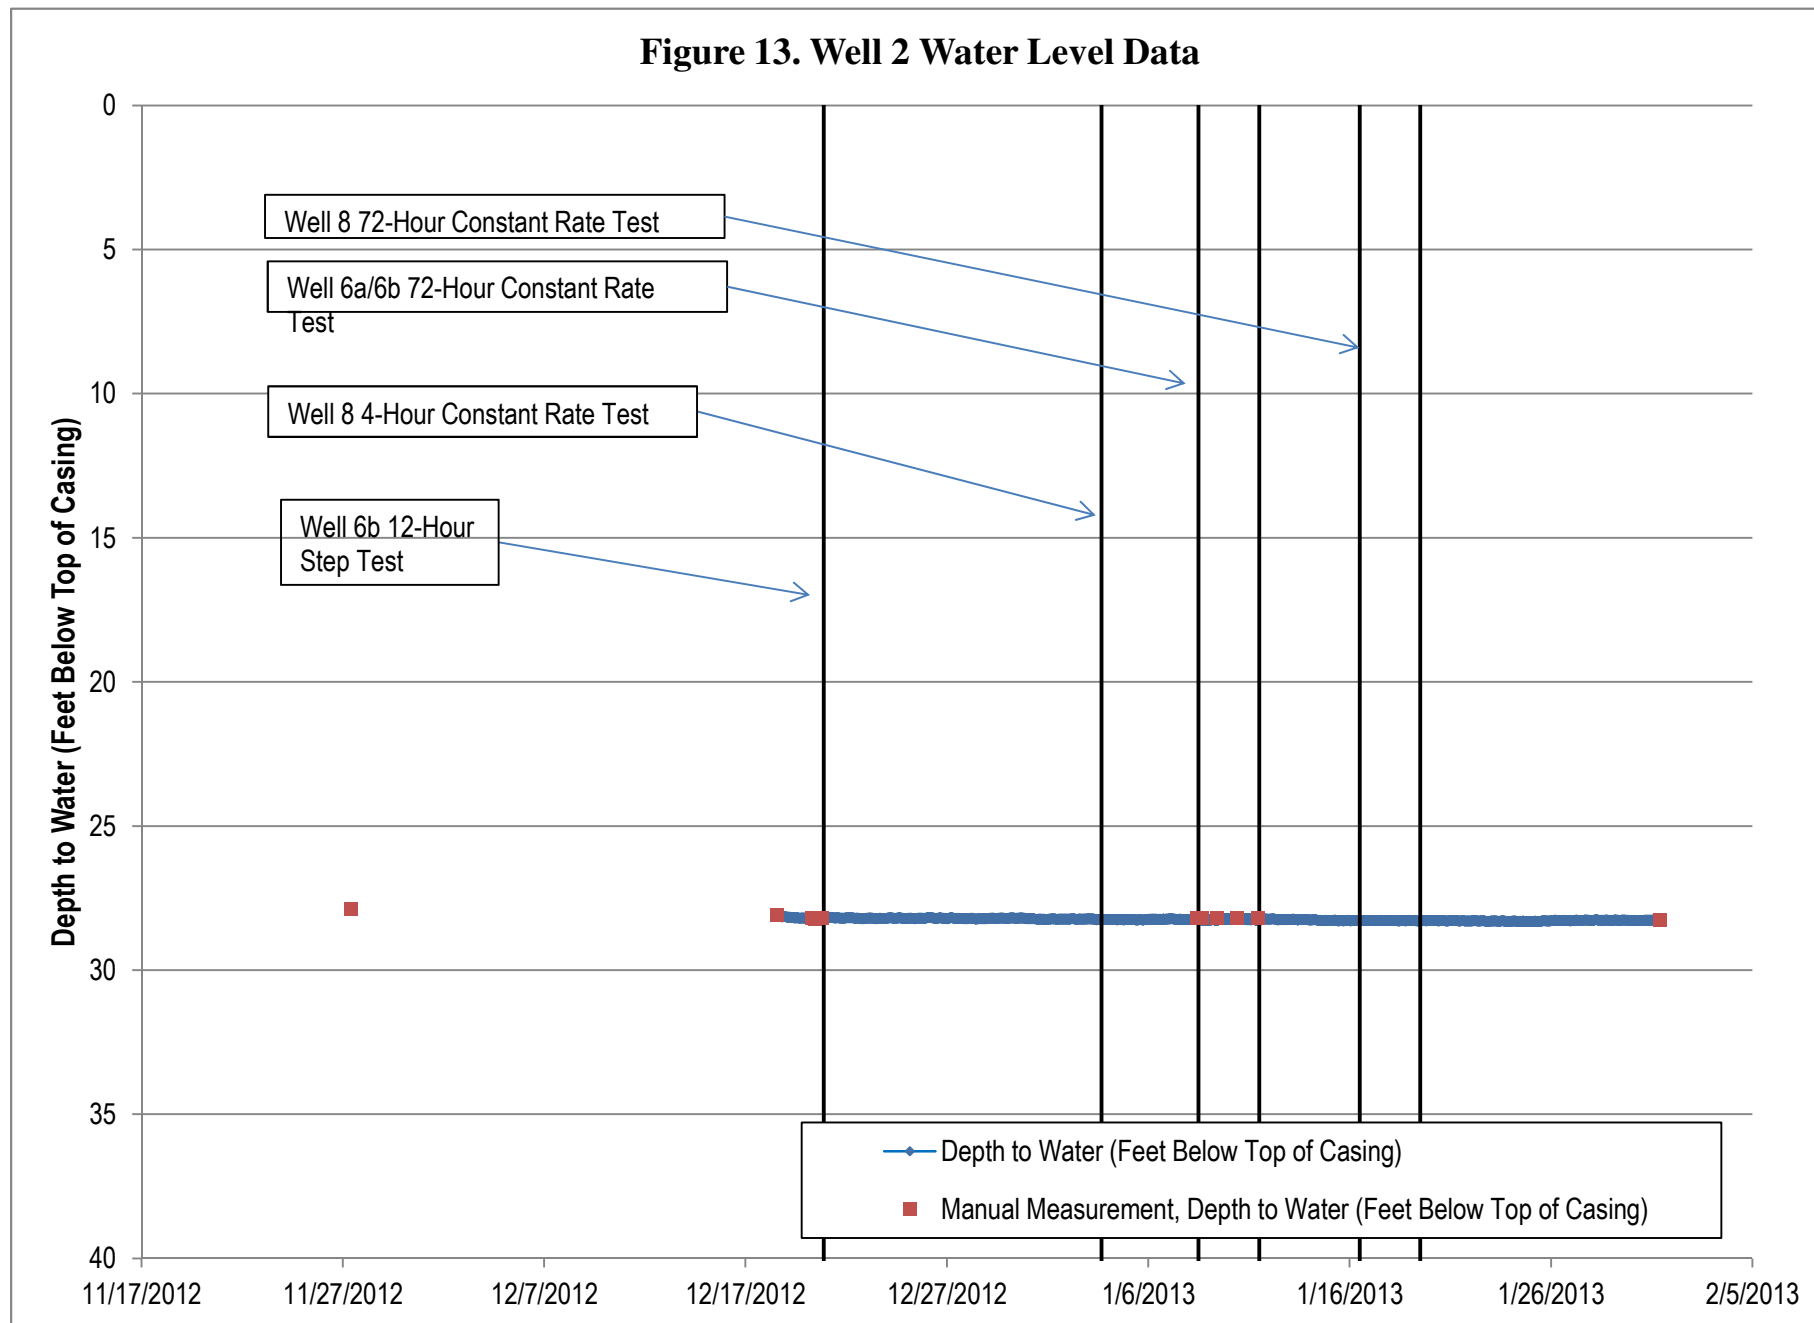
Figure 13. Well 2 Water Level Data

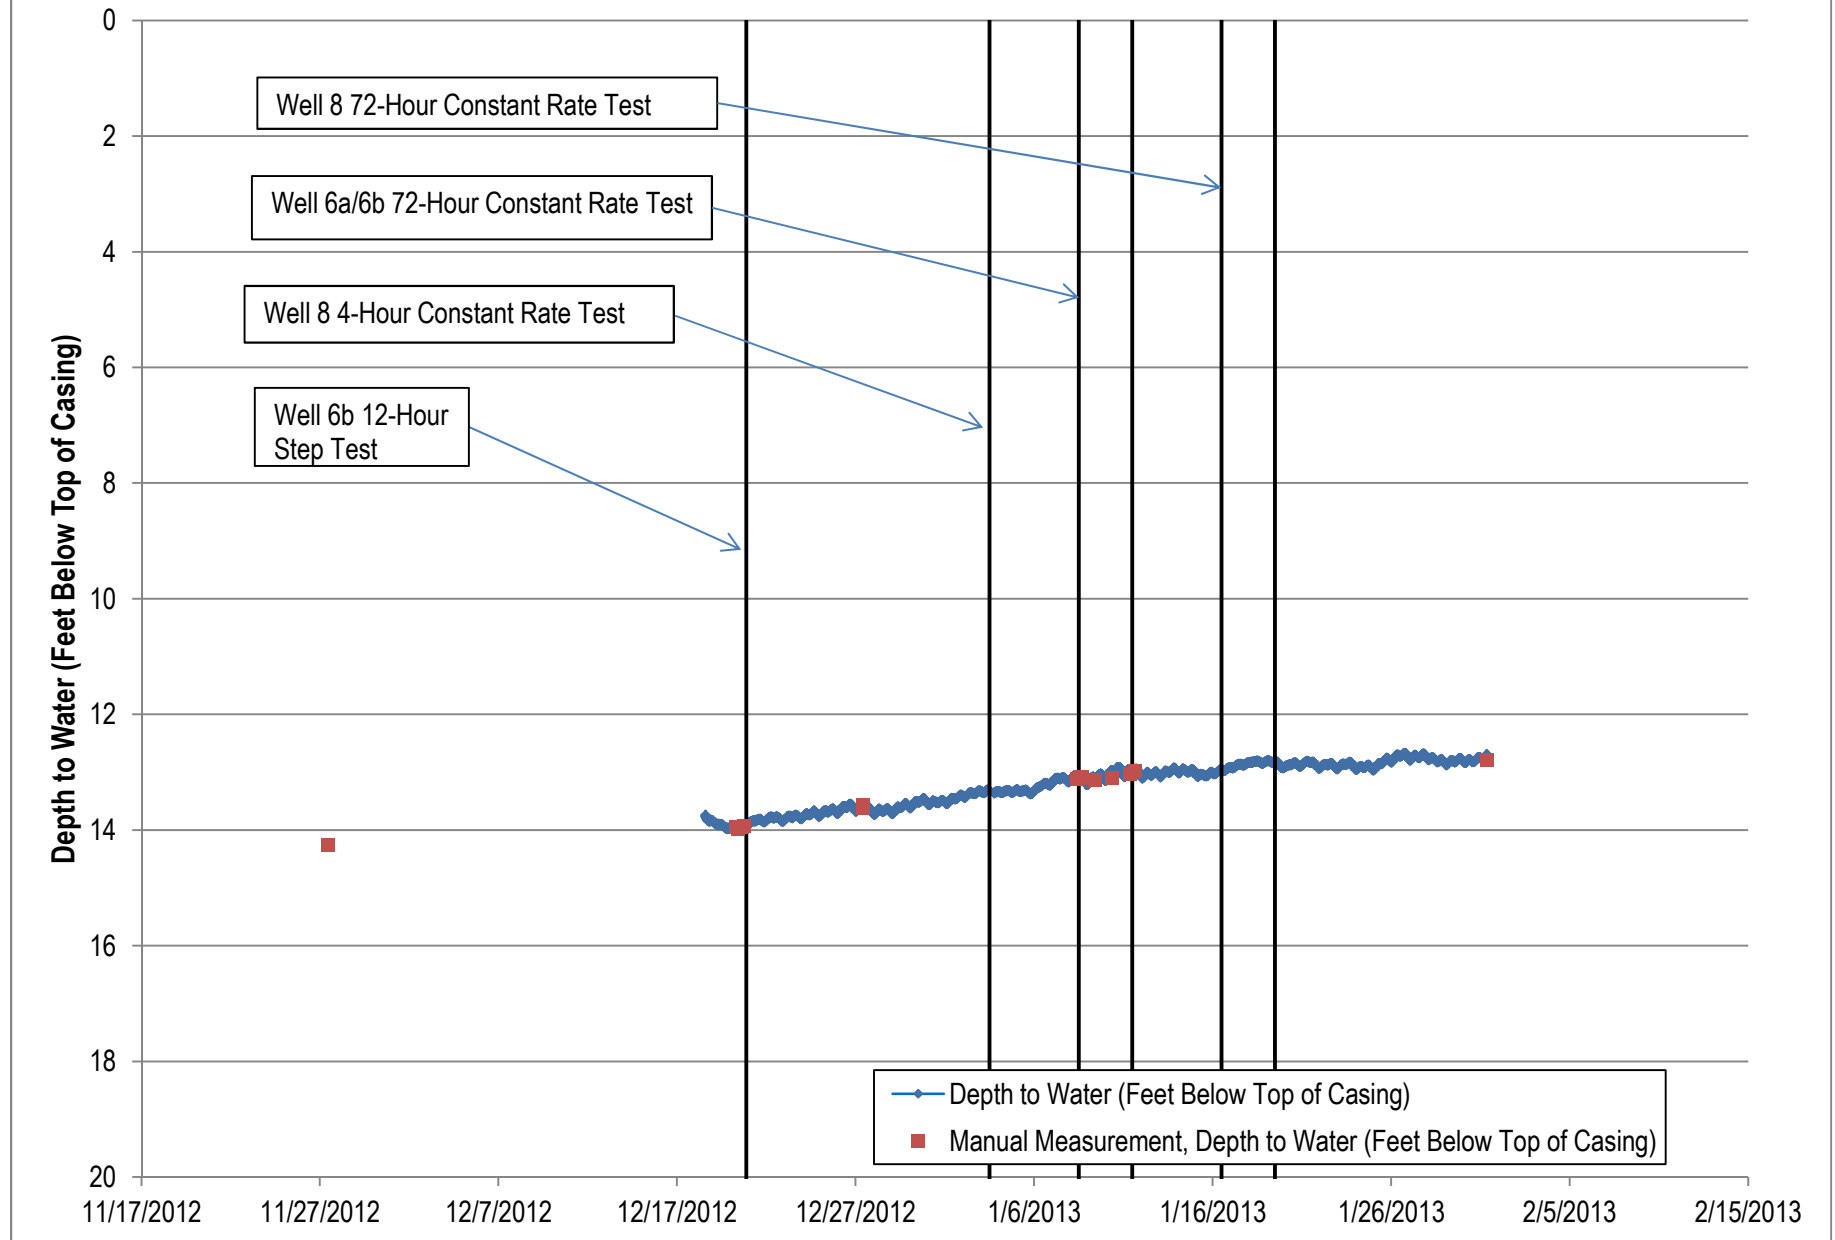
Figure 14. Well 3 Water Level Data

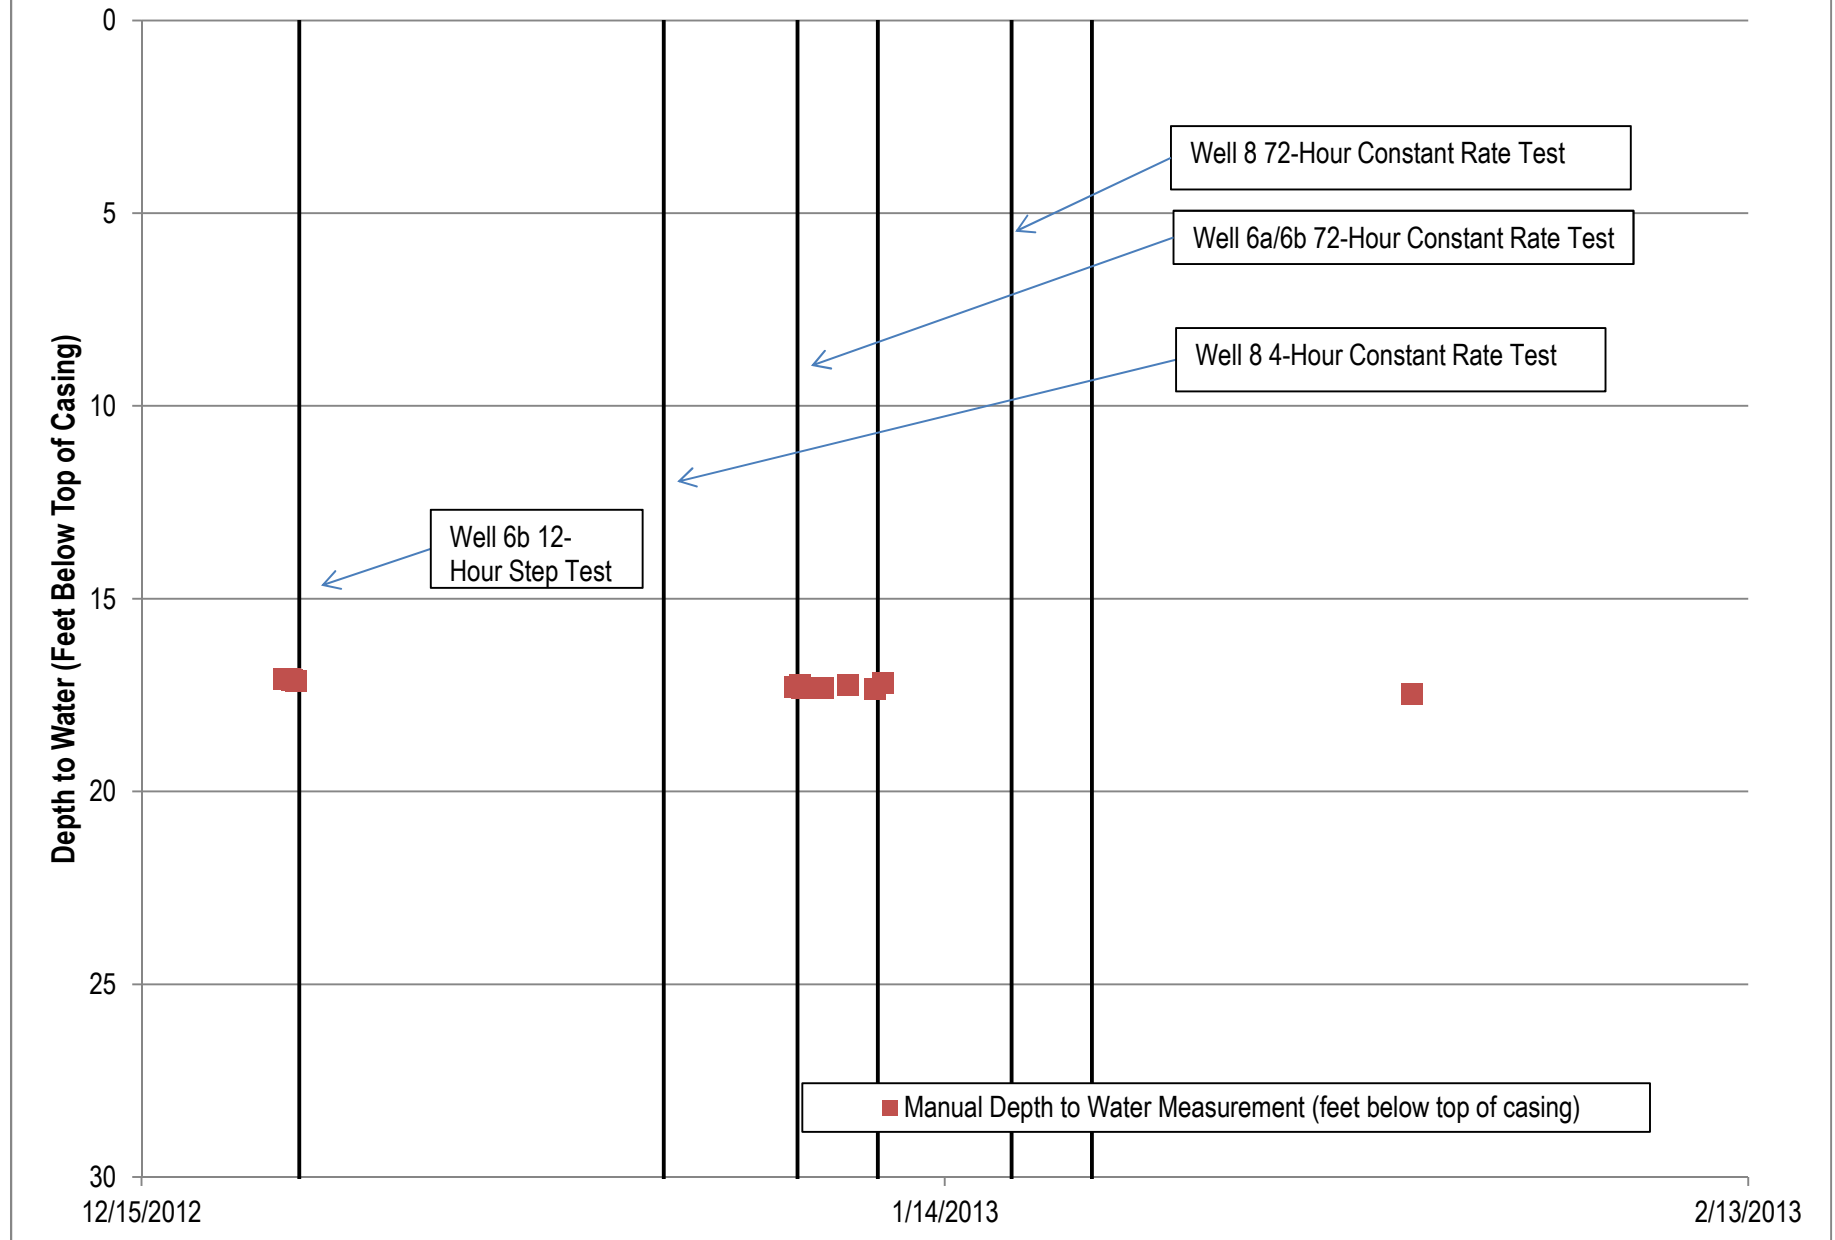
Figure 15. Well 4 Water Level Data

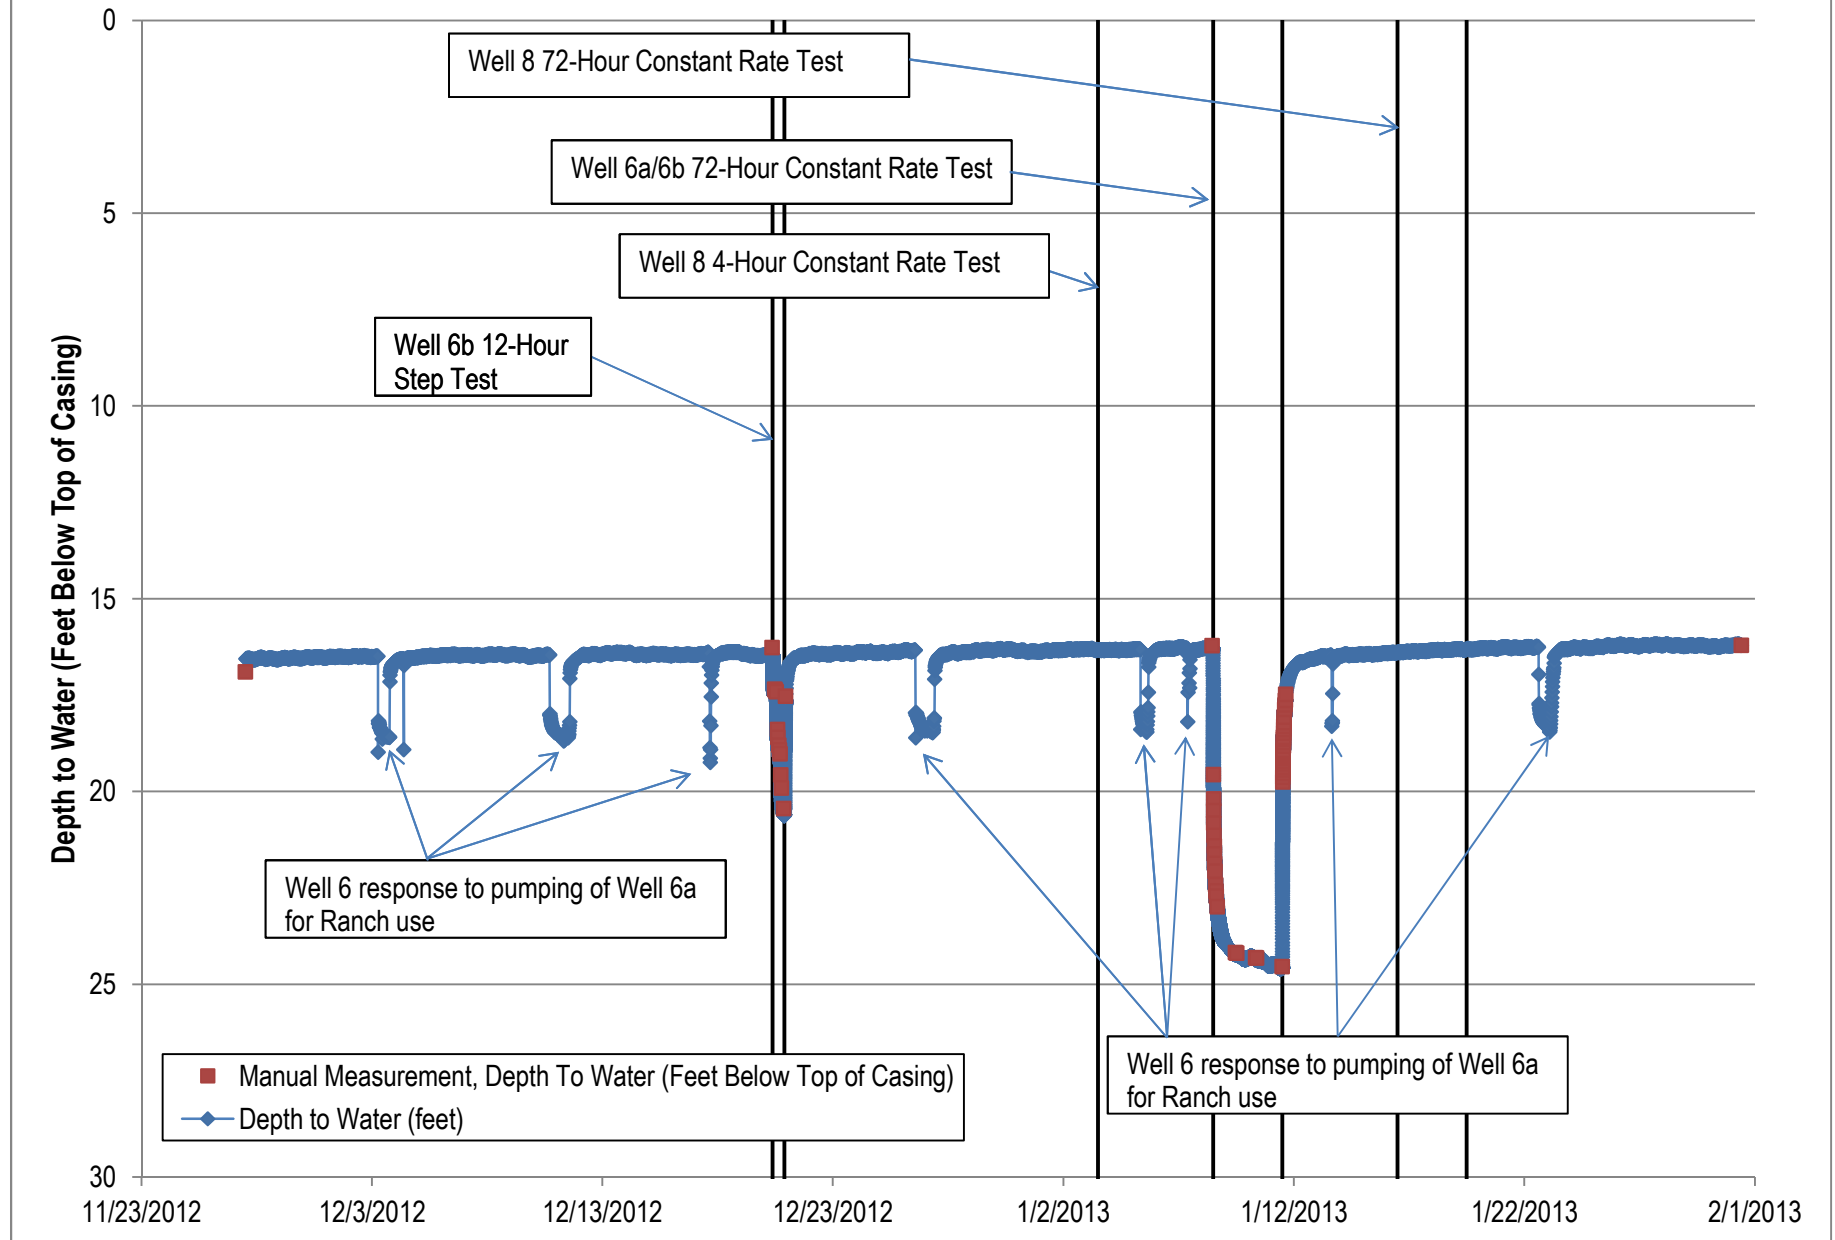
Figure 16. Well 6 Water Level Data
